BOB MOORE CONSTRUCTION

Pioneer 360 Business Center:

Overcoming the Challenges of Infill Development to Deliver a Gold LEED for Core & Shell Project

White Paper

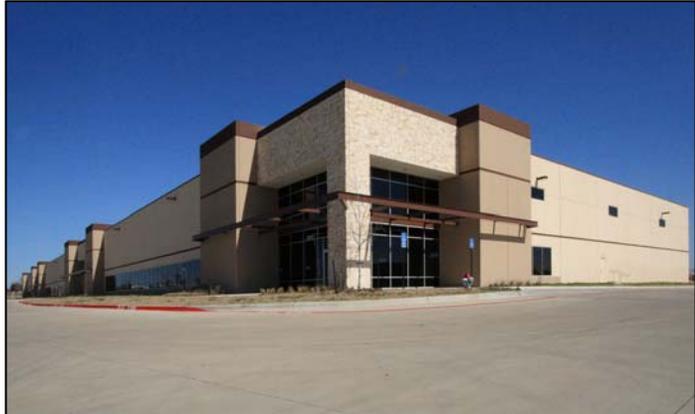
Buildings A (194,845 SF) and B (152,800 SF) support flex tech, office, showroom, and rear-load warehouse operations for up to four independent tenants per building. Both buildings feature a combined 96 loading dock bays and ribbon glass bands on the front walls, with two-tone paint finishing and stone facade corner entrances on the exterior.

Building C is an 815,820 SF cross-dock distribution center designed to house up to six tenants. It is finished with a two-tone paint scheme, and includes more than 100 trailer storage spaces. Building C includes 158 loading dock bays. All three buildings were built with tilt-up construction.

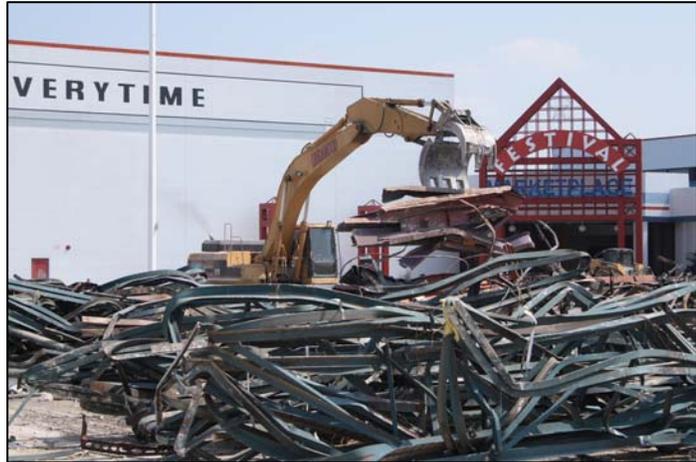
As part of the qualifications for LEED certification, we established a target of recycling 95% or more of materials taken from the demolished mall rather than sending them to landfill. To ensure we stayed on track for this goal we had to manage the materials carefully as we pulled them from the building.

As the mall came down, workers separated the materials into different stacks, which were ultimately loaded and taken to recycling companies. Workers tracked amounts of materials as they were shipped out to ensure we met our goal and could accurately report how the various waste materials were disposed of.

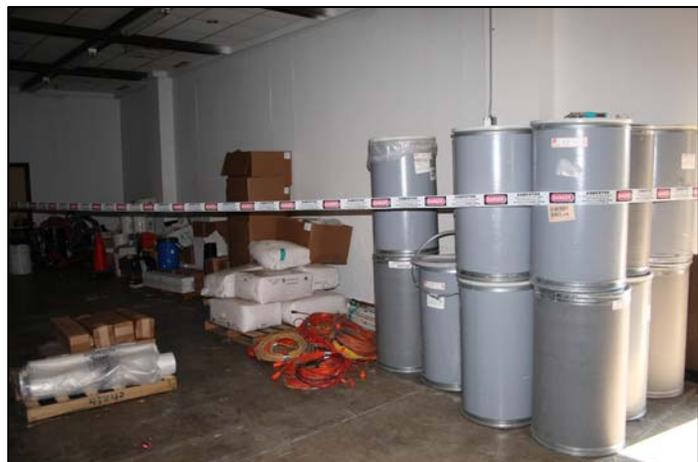
Asbestos. Asbestos is a common problem that must be addressed during infill development projects, when older buildings are taken down to be replaced by new and improved ones.

The mall demolished during the Pioneer 360 Business Center project was built in 1970. As was common for buildings from that era, the materials used to construct portions of the mall included asbestos.

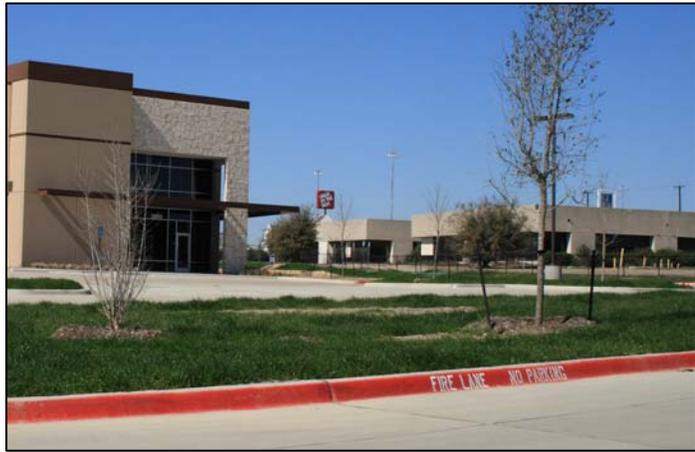
Many of the water, sewer and power lines were not well documented and we had to use great caution when removing the parking lot and doing the site work. Not only was this a potential safety hazard for our workers. Several businesses along the north side of the mall (as shown in the picture to the right) were still using the old infrastructure and any interruptions to services would have shut them down.

Through the use of an old drawing from 1970 when the mall was originally built, we had a general idea where the utilities would be. We pot-holed areas where we thought the utilities should be to locate them, and then used appropriate best management practices to expose and protect the utility lines as site work progressed. Prior contact with the utility companies was also helpful to finally identify these lines so our workers could proceed on with prepping the site and locating the utility lines before they were damaged by the heavy equipment.
