## **Pioneer 360 Business Center:**

Overcoming the Challenges of Infill Development to Deliver a Gold LEED for Core & Shell Project

White Paper

October, 2009

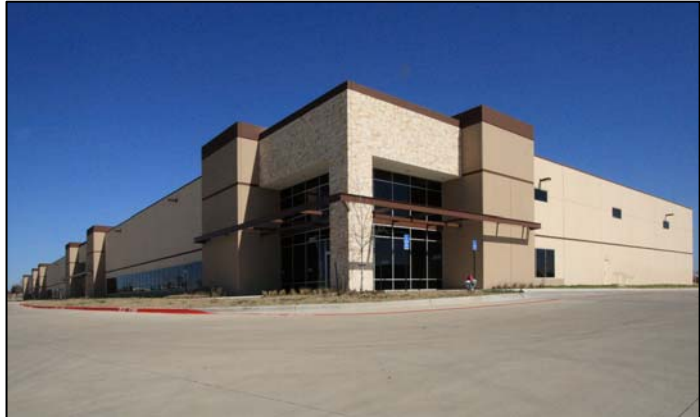
Buildings A (194,845 SF) and B (152,800 SF) support flex tech, office, showroom, and rear-load warehouse operations for up to four independent tenants per building. Both buildings feature a combined 96 loading dock bays and ribbon glass bands on the front walls, with two-tone paint finishing and stone facade corner entrances on the exterior.

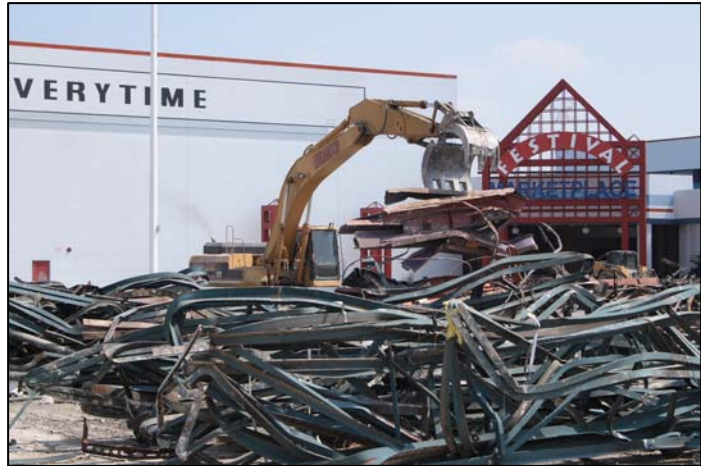
As part of the qualifications for LEED certification, we established a target of recycling 95% or more of materials taken from the demolished mall rather than sending them to landfill. To ensure we stayed on track for this goal we had to manage the materials carefully as we pulled them from the building.

As the mall came down, workers separated the materials into different stacks, which were ultimately loaded and taken to recycling companies. Workers tracked amounts of materials as they were shipped out to ensure we met our goal and could accurately report how the various waste materials were disposed of.

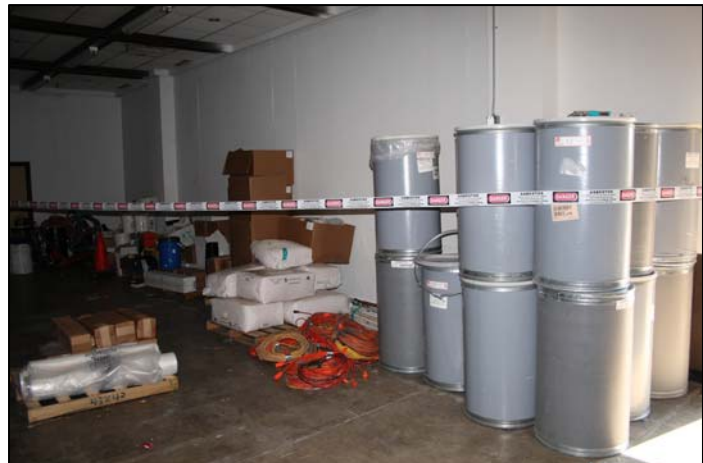
**Asbestos.** Asbestos is a common problem that must be addressed during infill development projects, when older buildings are taken down to be replaced by new and improved ones.

The mall demolished during the Pioneer 360 Business Center project was built in 1970. As was common for buildings from that era, the materials used to construct portions of the mall included asbestos.

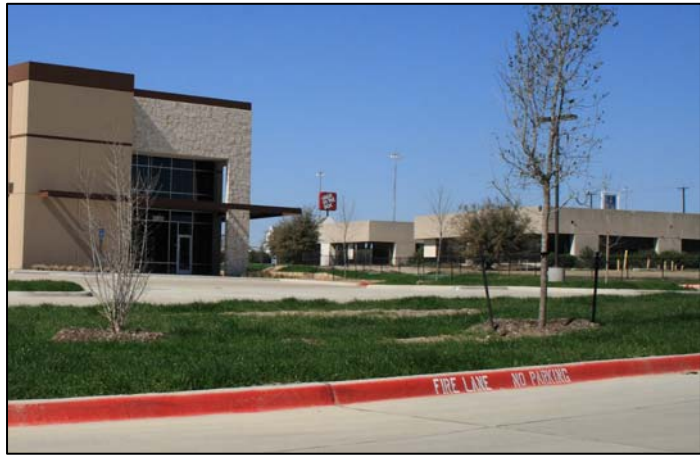
Many of the water, sewer and power lines were not well documented and we had to use great caution when removing the parking lot and doing the site work. Not only was this a potential safety hazard for our workers. Several businesses along the north side of the mall (as shown in the picture to the right) were still using the old infrastructure and any interruptions to services would have shut them down.

Through the use of an old drawing from 1970 when the mall was originally built, we had a general idea where the utilities would be. We pot-holed areas where we thought the utilities should be to locate them, and then used appropriate best management practices to expose and protect the utility lines as site work progressed. Prior contact with the utility companies was also helpful to finally identify these lines so our workers could proceed on with prepping the site and locating the utility lines before they were damaged by the heavy equipment.

The existing infrastructure was inadequate to the task of supporting the new business center, and we had to rebuild it as we prepared the site. To minimize impact on the other local businesses, we set up redundant utility lines and transitioned from old to new when it would have the least impact on the business center's neighbors.
